Manhole Inspection Summary

Manhole # S31YY1001MH

Location Address: **115 SAINT DUNSTANS RD**

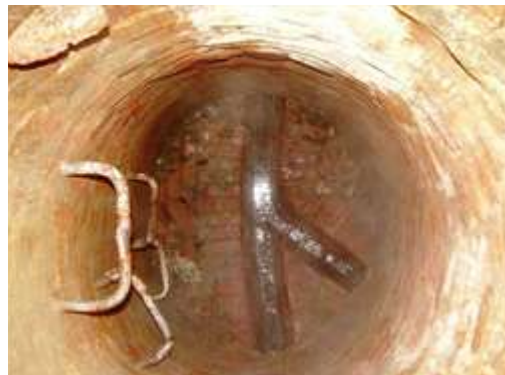
Top View

Bench debris.

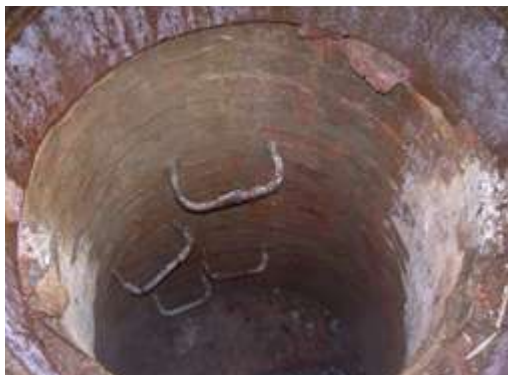
Defect

Frame leaks. Adjustment deterioration, loose brick and infiltration.

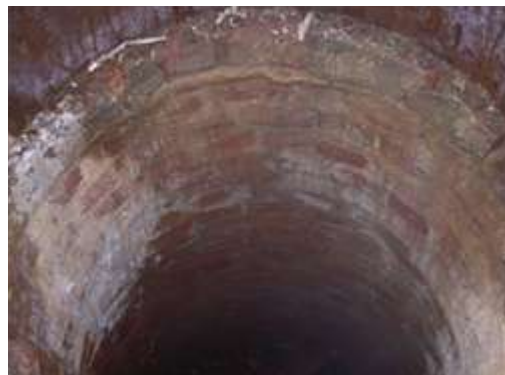
Defect

Frame leaks. Adjustment deterioration, loose brick and infiltration. Corbel infiltration - other side.

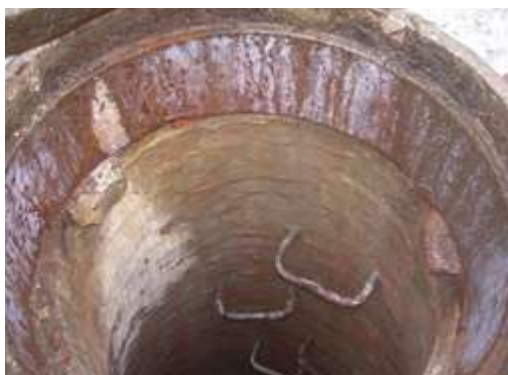
Defect

Frame leaks. Adjustment deterioration, loose brick and infiltration. Corbel infiltration.

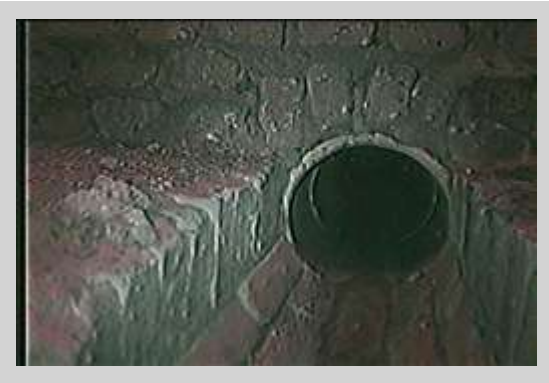
8 in. Circular Gravity Sewer Pipe Out @ 12 O'Clock

Invert Depth: **9.01** (ft.) Flow Characteristics: **Slow**

Infiltration: **None** Pipe Seal Cond: **Unknown**

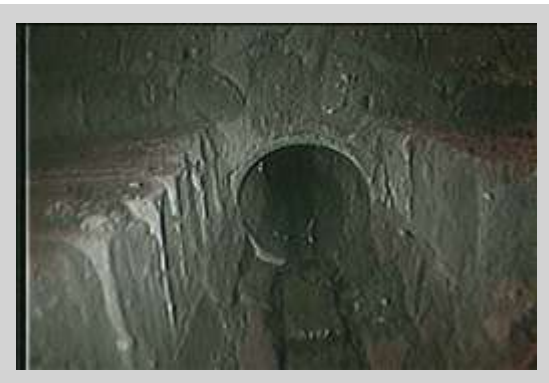
6 in. Circular Gravity Sewer Pipe In @ 4 O'Clock

Invert Depth: **8.93** (ft.) Flow Characteristics: **None**

Infiltration: **None** Pipe Seal Cond: **Unknown**

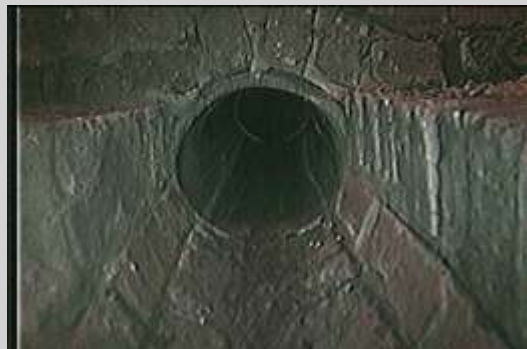
8 in. Circular Gravity Sewer

Infiltration: **Evidence**

Pipe Seal Cond: **Cracked**
